International Research Journal in Advanced Engineering and Technology (IRJAET)

Counteractive Measures and Malfunction Analysis of Boiler Economizer Tube

3.1 Economizer specification

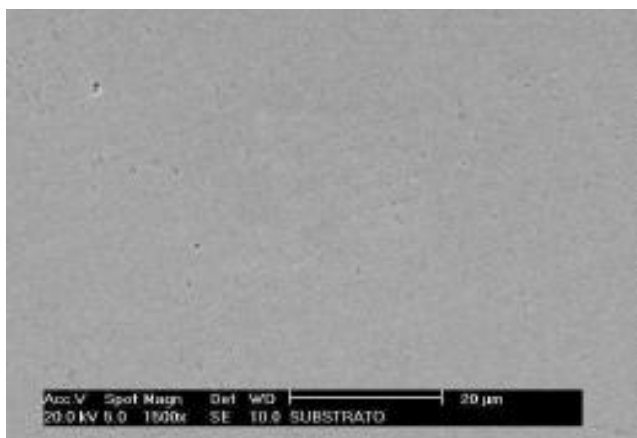
Figure 2 Before erosion

Visual examination using a scanning electron microscope (Fig 2) has shown that morphology of SAE210GA1 seamless medium carbon steel indicated a uniform distribution of crystal without any deposits, and with uniform orientation.

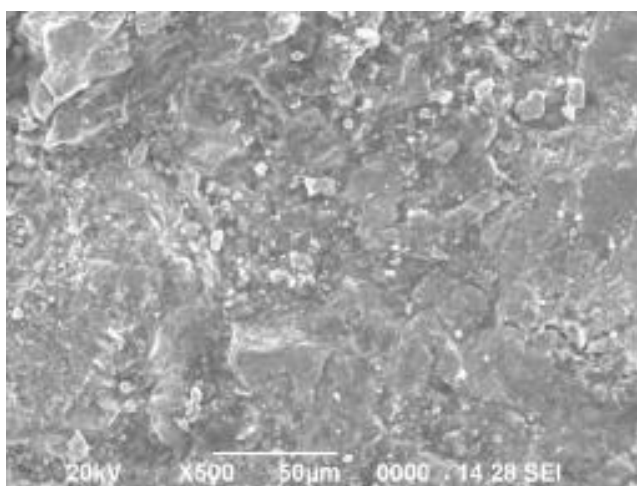
Figure 3 After erosion

Visual examination of eroded tube showed a “rocklike” crystal structure, changes in orientation and deposit formation. Rock like crystal structure is due to agglomeration. The figure (5.3) showed the uneven surface of eroded tube.

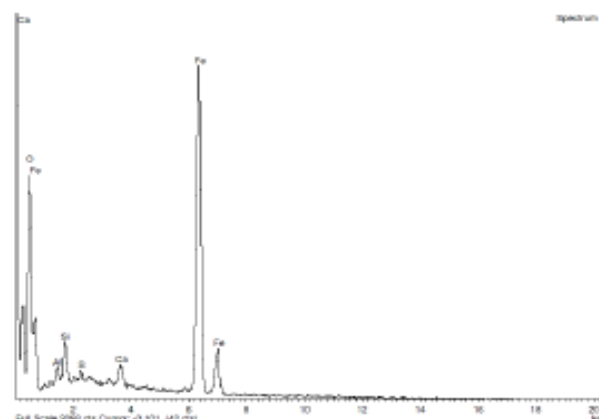
Figure 5 EDAX Graph Showed Chemical Composition of Deposits

Element	Element %	Atomic %
O	40.76	68.42
Al	1.48	1.48
Si	3.66	3.50
S	0.78	0.66
Ca	1.68	1.12
Fe	51.63	24.82

The agglomeration of the above individual element is the reason for “rock morphology” and change in orientation of the crystal.

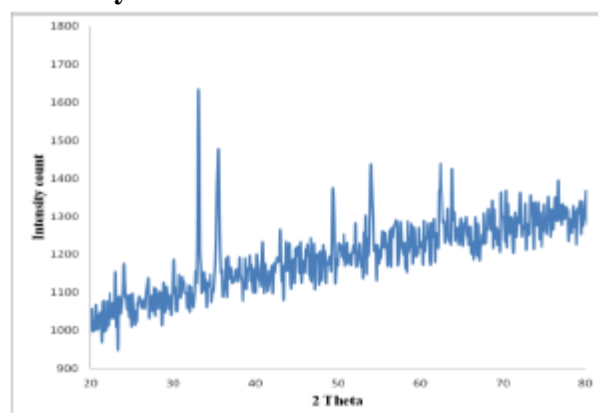
Figure 6 X-ray diffraction graph indicating the structural changes of eroded tube

The X-ray diffraction to indicate the uneven surface of eroded tube and also graph showed the structural changes.
